### **JURISDICTIONAL EVALUATION REPORT**

**Whitehouse Road Property**

**Jasper, Walker County, Alabama**

Environmental, Inc. Project No.: SAI01E2307

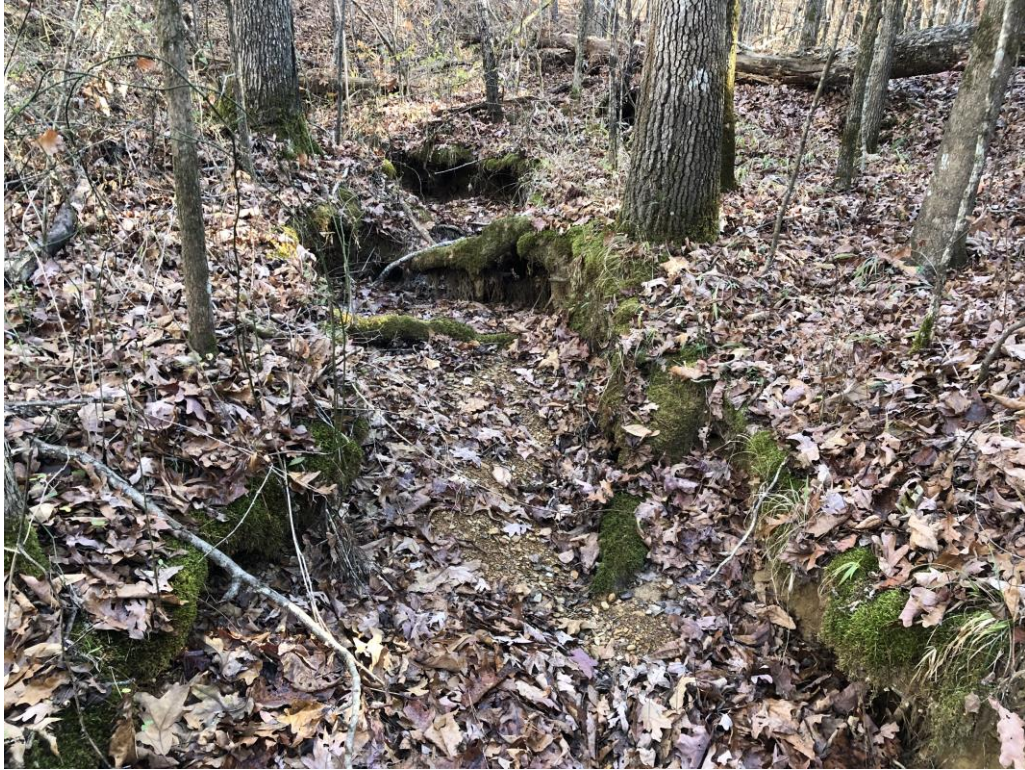
**Stream 1** originates along the northwestern boundary of the project area and flows north for approximately 757 linear feet before flowing into a culvert under 29<sup>th</sup> Street E. Stream 1 is centered at latitude 33.82146° north and longitude 87.26005° west, has a defined OHWM of 1 to 4 feet, and is classified as ephemeral.

View of Stream 1.

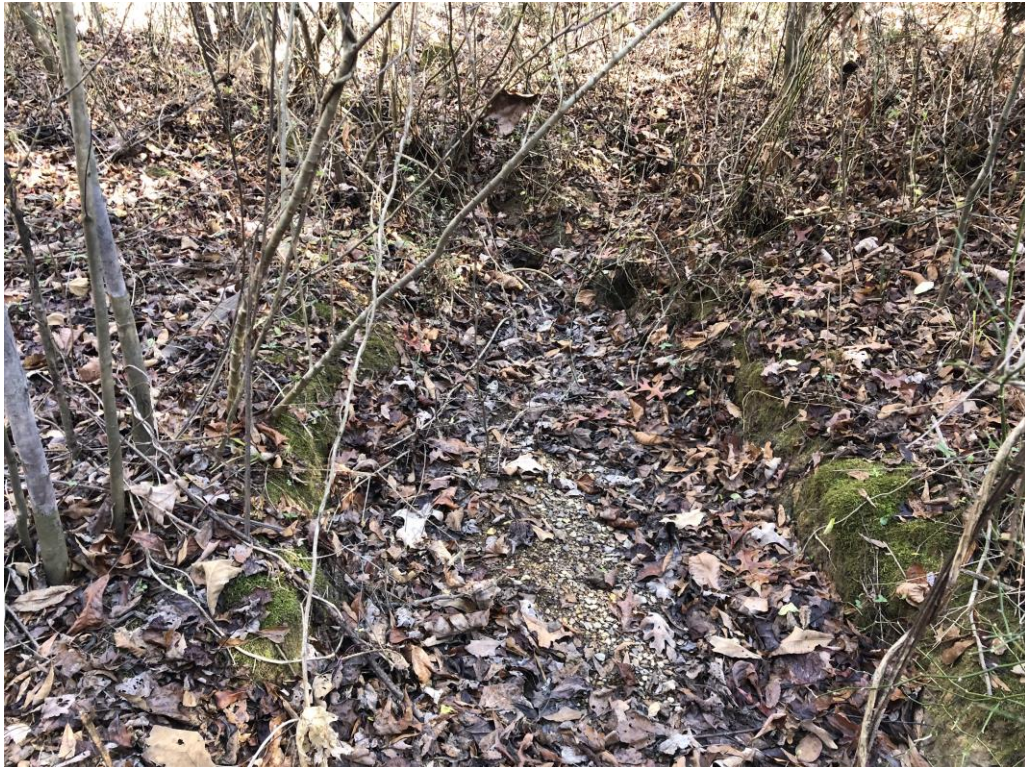
**Stream 2 (Ephemeral)** originates in the central-western portion of the project area and flows west for approximately 221 linear feet before transitioning into Stream 2 (Intermittent). Stream 2 (Ephemeral) is centered at latitude 33.8184° north and longitude 87.25997° west, has a defined OHWM of 1 to 2 feet, and is classified as ephemeral.

View of Stream 2 (Ephemeral).

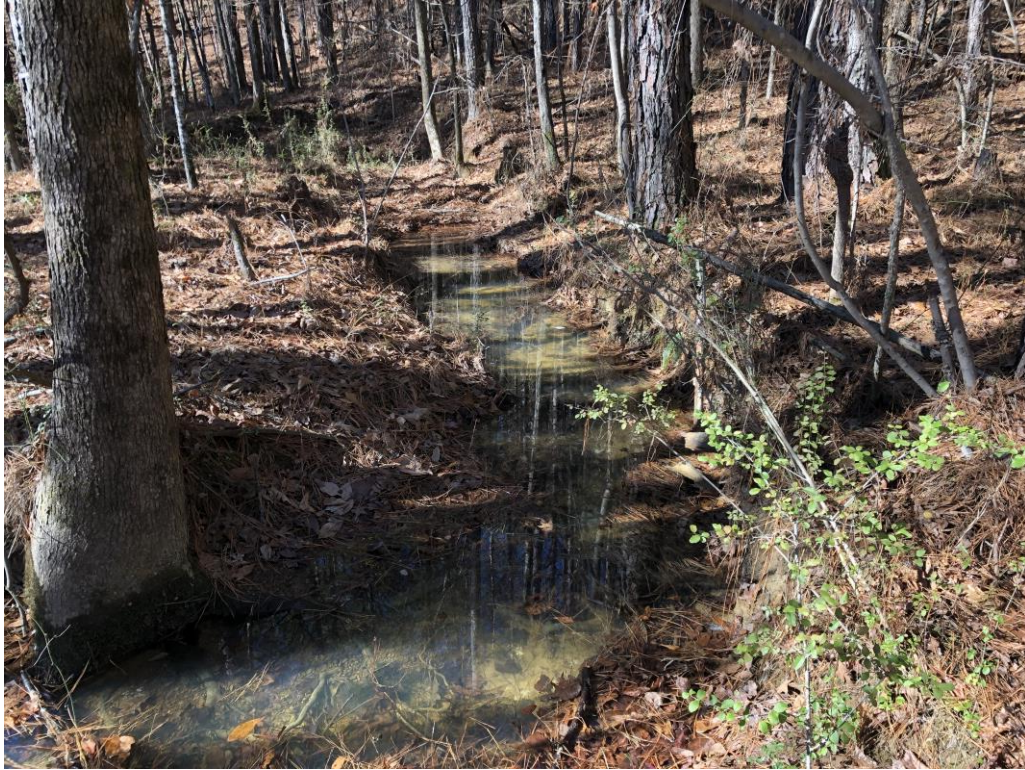
**Stream 2 (Intermittent)** is a continuation of Stream 2 (Ephemeral) and flows south for approximately 1,486 linear feet before exiting the project area on the southwestern boundary. Stream 2 (Intermittent) is centered at latitude 33.81705° north and longitude 87.26086° west, has a defined OHWM of 1 to 5 feet, and is classified as intermittent.

View of Stream 2 (Intermittent).

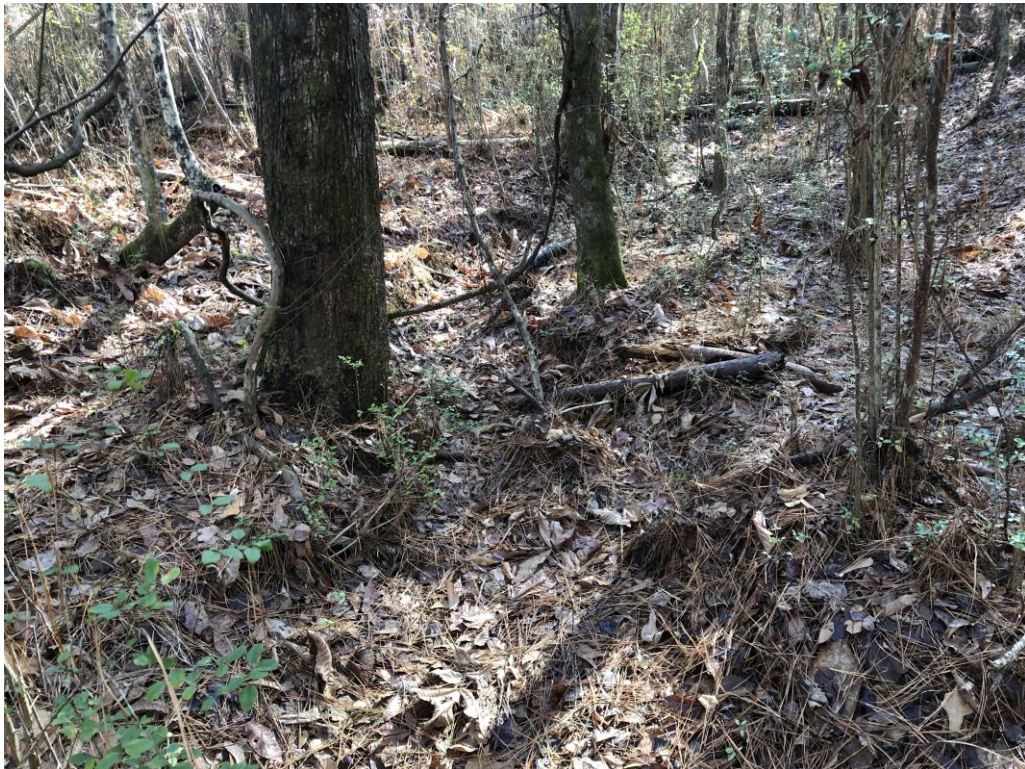
**Stream 3** originates in the central-western portion of the project area and flows southeast for approximately 674 linear feet before flowing into Stream 2 (Intermittent). Stream 3 is centered at latitude 33.81864° north and longitude 87.26116° west, has a defined OHWM of 1 to 2 feet, and is classified as ephemeral.

View of Stream 3.

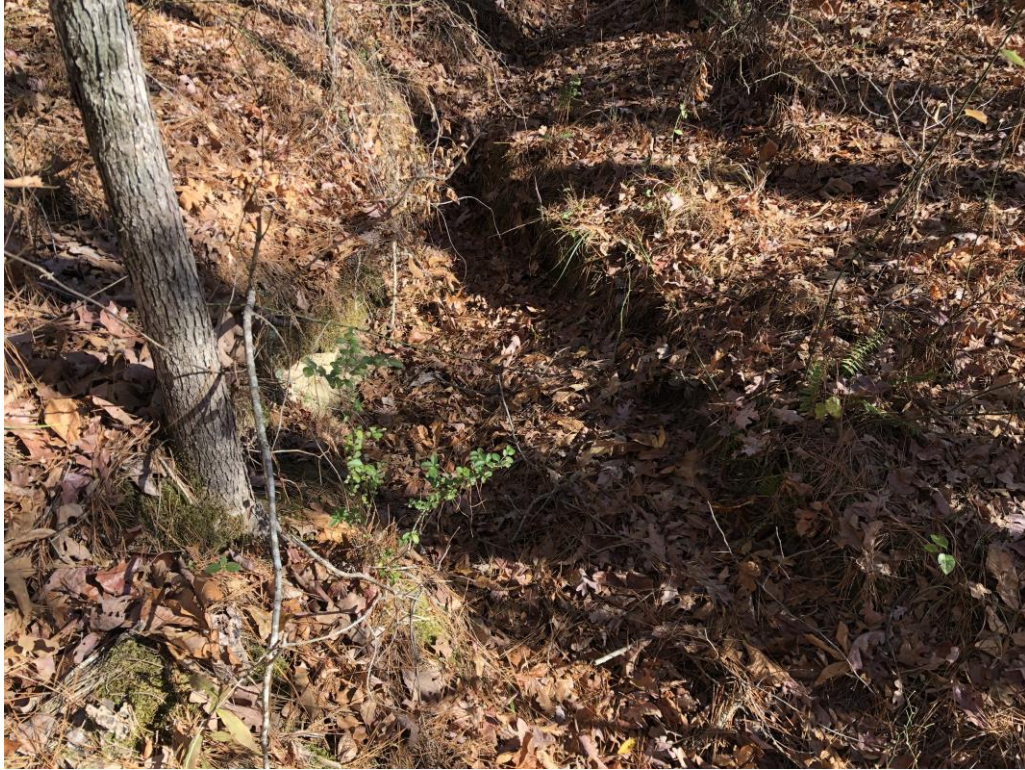
**Stream 4** originates in the central portion of the project area and flows southwest for approximately 641 linear feet before flowing into Stream 2 (Intermittent). Stream 4 is centered at latitude 33.81766° north and longitude 87.25936° west, has a defined OHWM of 1 to 2 feet, and is classified as ephemeral.

View of Stream 4.

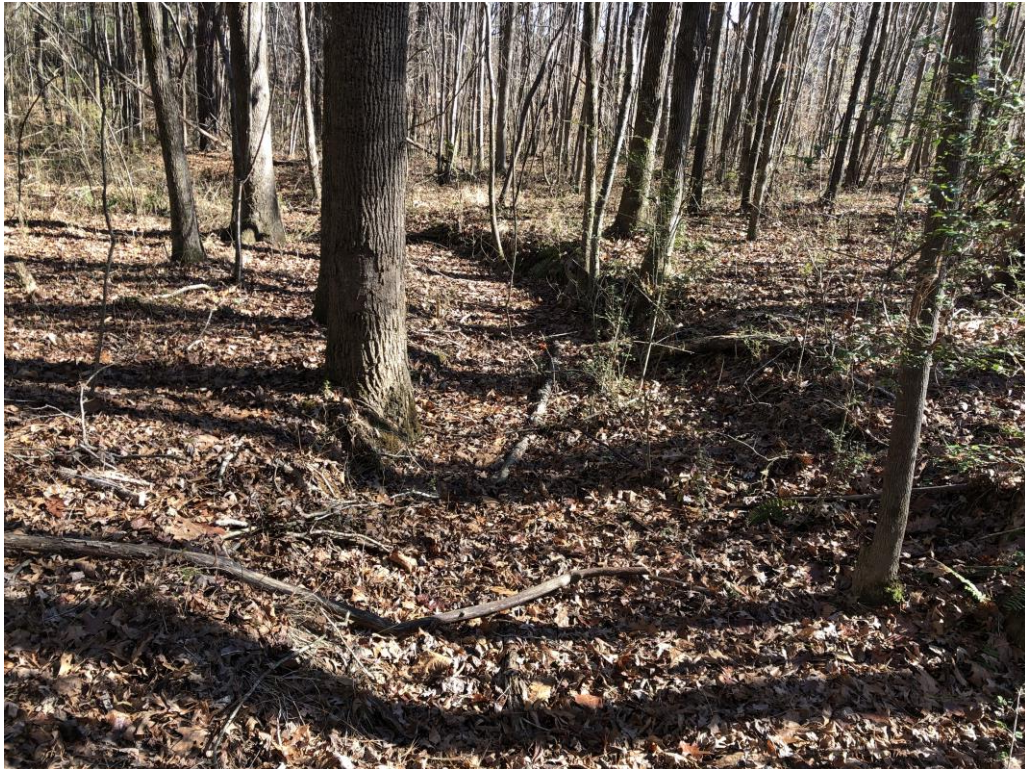
**Stream 5** originates in the southwestern portion of the project area and flows southeast for approximately 526 linear feet before flowing into Stream 2 (Intermittent). Stream 5 is centered at latitude 33.81627° north and longitude 87.26134° west, has a defined OHWM of 0.5 to 2 feet, and is classified as ephemeral.

View of Stream 5.

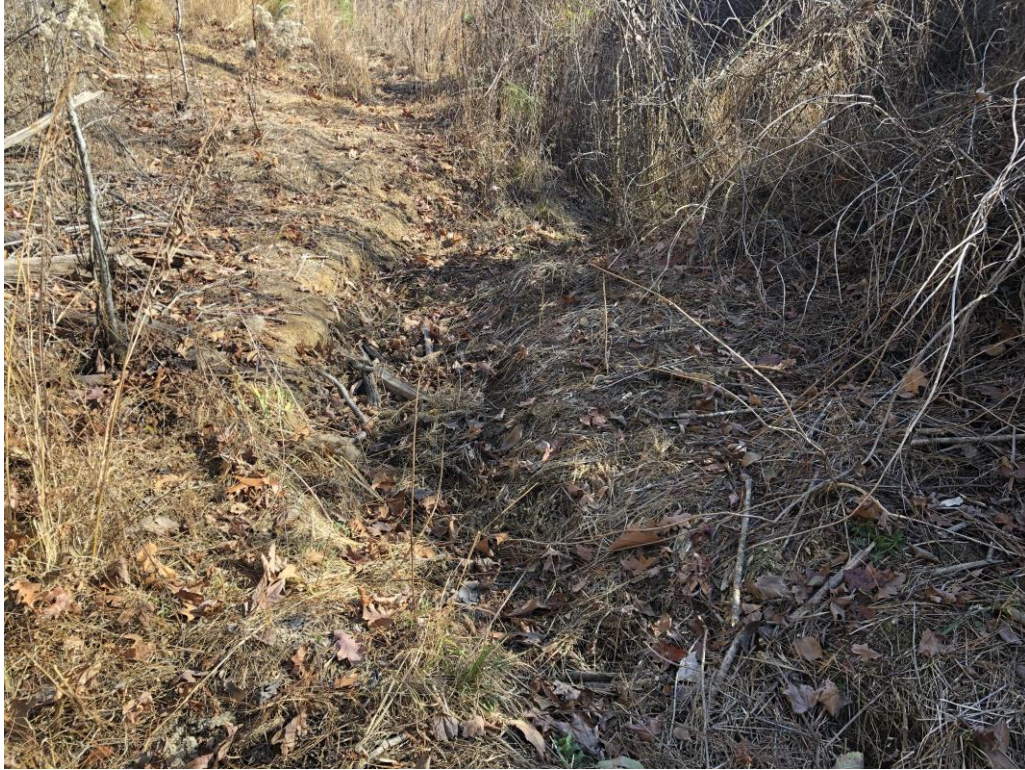
**Stream 6 (Ephemeral)** originates in the southeastern portion of the project area and flows southwest for approximately 243 linear feet before the bed and bank dissipates and the stream flows laminarily across Wetland 1 and then reconstitutes and continues southwest for an additional 135 linear feet before exiting the project area on the southeastern boundary. Stream 6 (Ephemeral) then flows across the south-central boundary of the project area and continues for an additional 313 linear feet before transitioning into Stream 6 (Intermittent). Stream 6 (Ephemeral) is centered at latitude 33.81568° north and longitude 87.2574° west, has a defined OHWM of 0.5 to 2 feet, and is classified as ephemeral.

View of Stream 6 (Ephemeral).

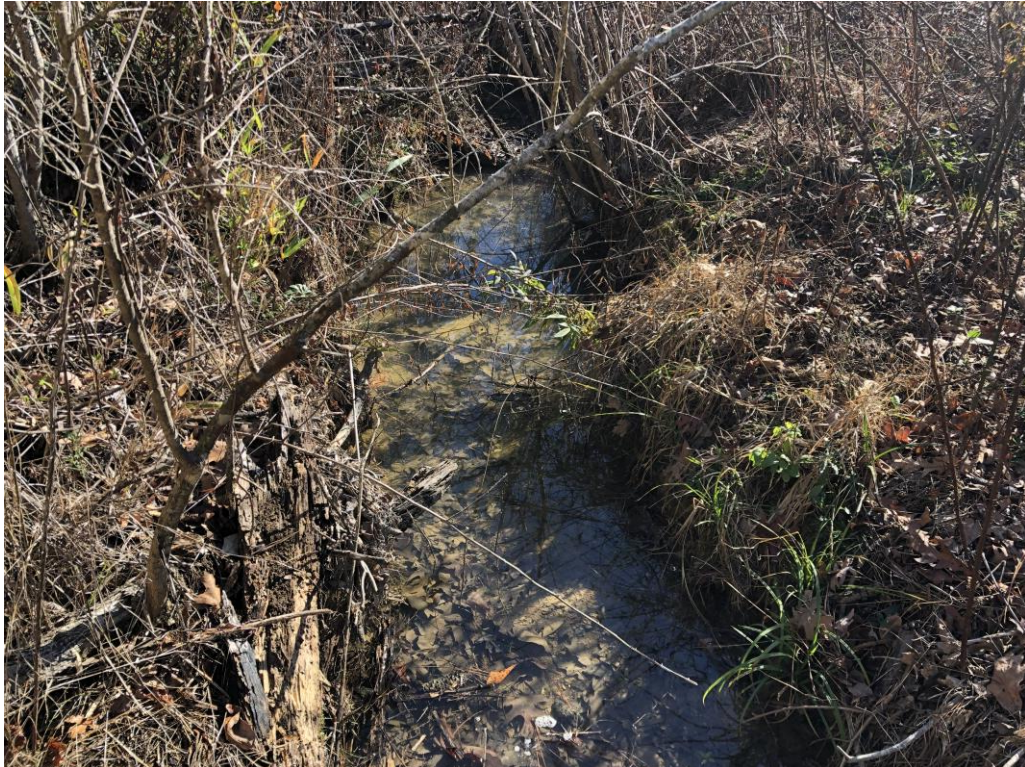
**Stream 6 (Intermittent)** is a continuation of Stream 6 (Ephemeral) and flows west for approximately 484 linear feet before flowing into Stream 2 (Intermittent). Stream 6 (Intermittent) is centered at latitude 33.81586° north and longitude 87.25995° west, has a defined OHWM of 1 to 3 feet, and is classified as intermittent.

View of Stream 6 (Intermittent).

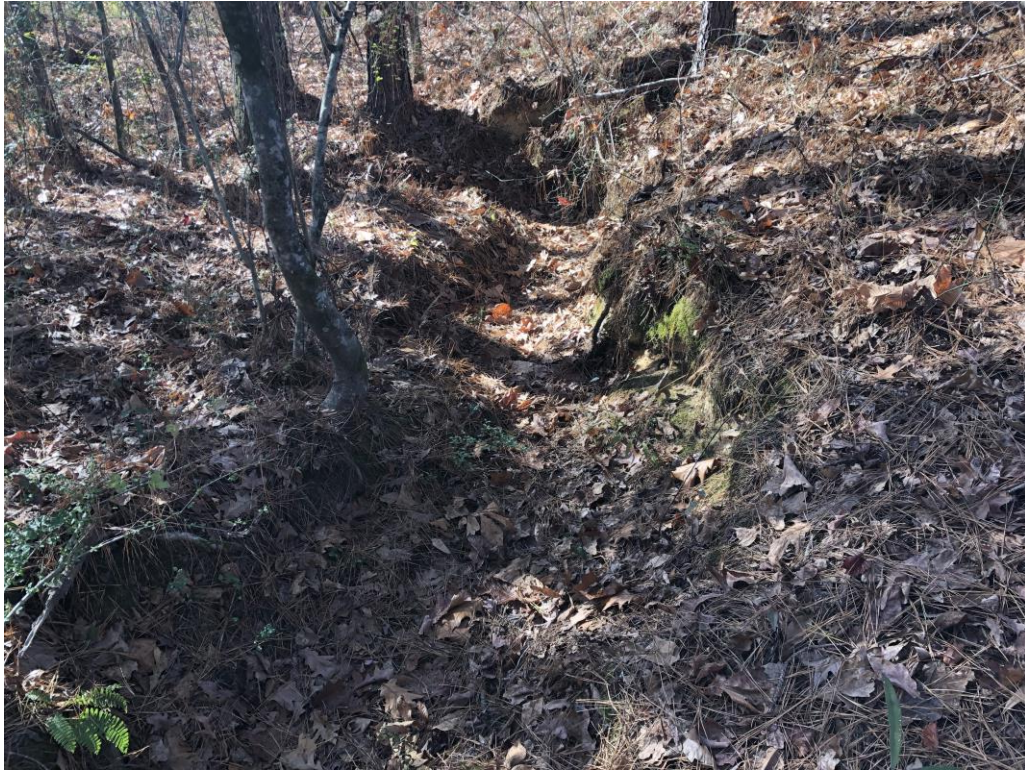
**Stream 7** originates in the central portion of the project area and flows southwest for approximately 981 linear feet before flowing into Stream 6 (Intermittent). Stream 7 is centered at latitude 33.81701° north and longitude 87.25854° west, has a defined OHWM of 1 to 3 feet, and is classified as ephemeral.

View of Stream 7.

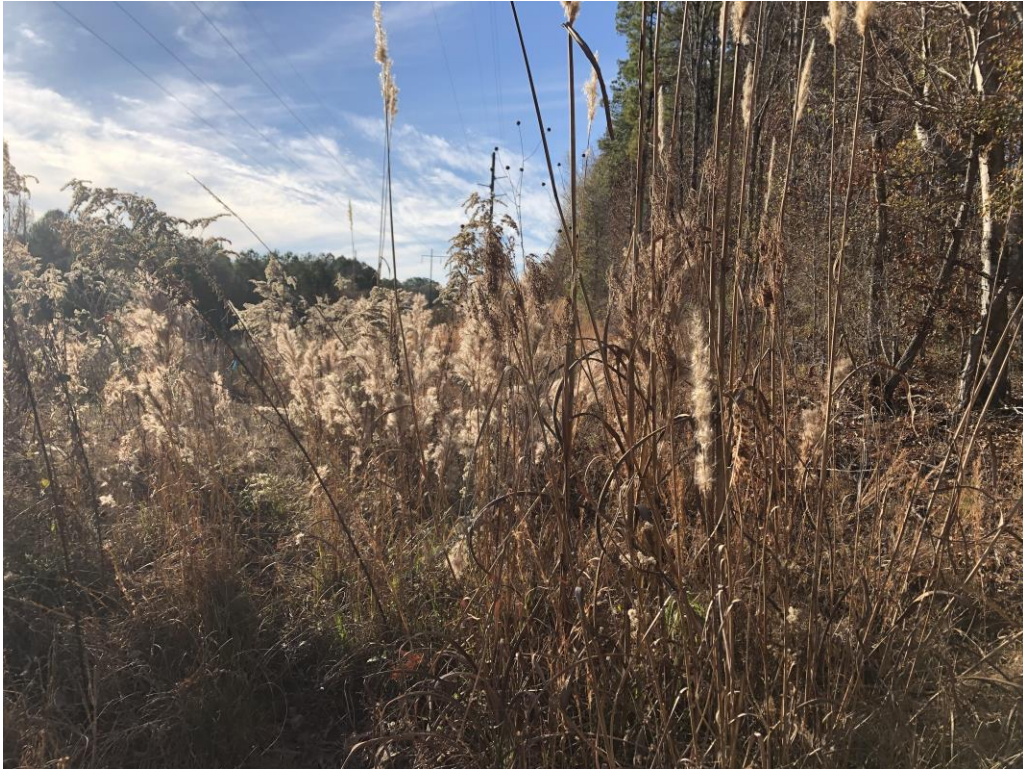
**Wetland 1** is centered at latitude 33.81595° north and longitude 87.25691° west. Wetland 1 is classified as an emergent wetland abutting Stream 8. Wetland 1 contains hydrophytic vegetation including bushy bluestem (*Andropogon glomeratus*), giant plumegrass (*Saccharum giganteum*), tall goldenrod (*Solidago gigantea*), and common rush (*Juncus effusus*). Wetland 1 is approximately 0.02 acres in size and was saturated seven inches from the surface at the time of the evaluation.

View of Wetland 1.
